Modern Lightning Conductors:

AN ILLUSTRATED SUPPLEMENT TO THE
REPORT OF THE LIGHTNING RESEARCH COMMITTEE
OF 1905,

Also the PHŒNIX FIRE OFFICE 1910 RULES,

KILLINGWORTH HEDGES,

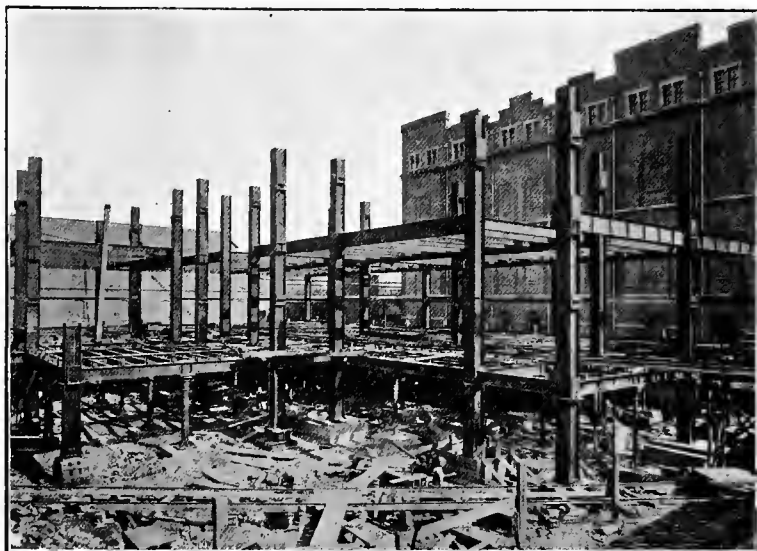
FIG. 35.

Fig. 35 is taken from a photograph of a building under construction. The author recommended the placing of aigrettes (Fig. 8) at intervals on the roofs, and joining these by cable conductors to

the metal principals below, iron rods were also fixed to the columns above the concrete foundations and inter-connected with earths sunk into moist ground.

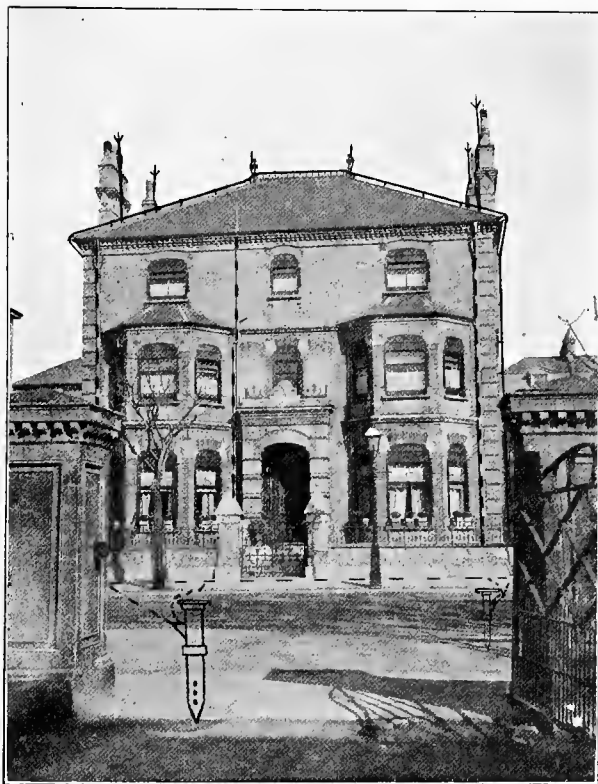
FIG. 37.

The following is a Specification of the conductors on a detached residence at Hove. Fig. 37. A horizontal $\frac{3}{8}$ -inch diameter cable of 7 strands iron wire is run across the ridge, but kept away by special

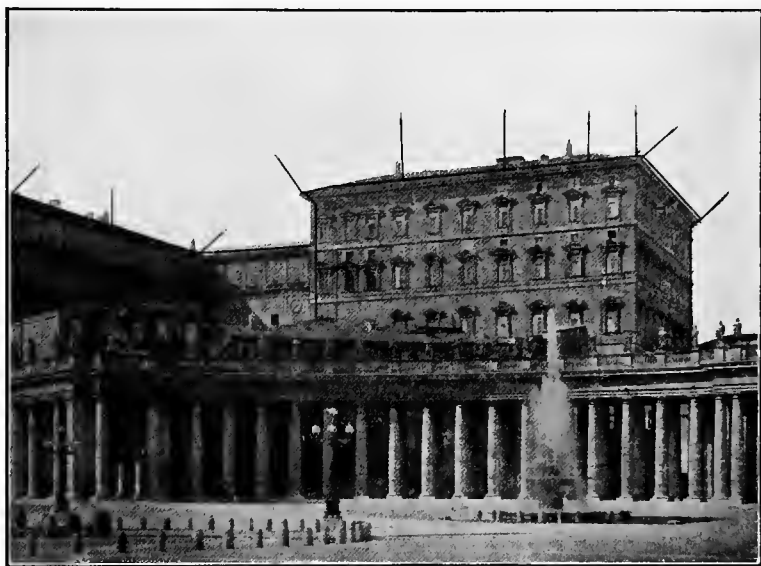
FIG. 40—THE VATICAN.

Vatican buildings, (Fig. 40) are also excellently protected—the high air terminals are built into stone-work projections evidently intended for ventilation, the system of iron conductors is clamped to the base of these vertical rods and is continued over the roofs, being kept away from the tiles by resting on marble supports, and at the end of each ridge an air terminal is arranged to project over the side of the roofs at an angle of about 60 degrees. The use of iron rod enables the protection of this the largest palace in the world to be

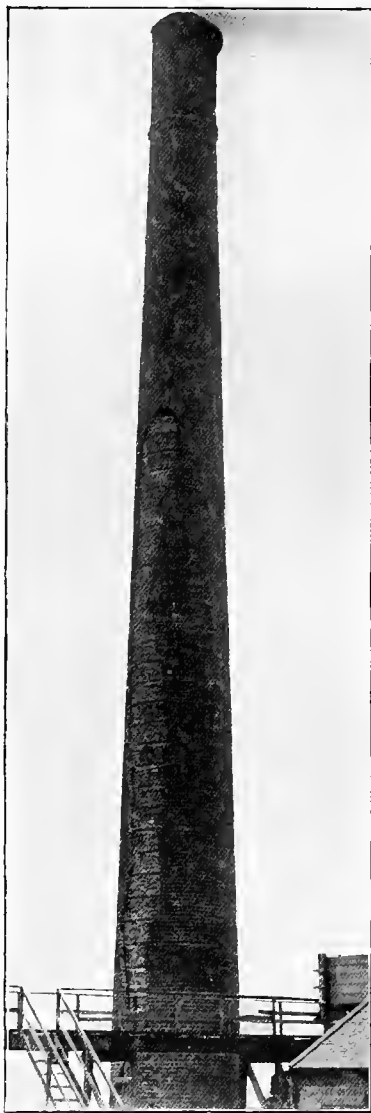
FIG. 46.

The high chimney was struck during a heavy hailstorm; the air terminal of three points was found hanging over the top. The rod was continuous, but where it passed the base of the stack, it was insulated from an iron strengthening band, leaving a space between the insulator and band of half an inch. The chimney was cracked in much the same way as Fig. 46, the bottom of the fault being near the roof of an adjacent shed. The stack had to be taken down.

NOTE.—Instead of being insulated the rod should have been connected to the iron band; it would have been advisable to have run a second

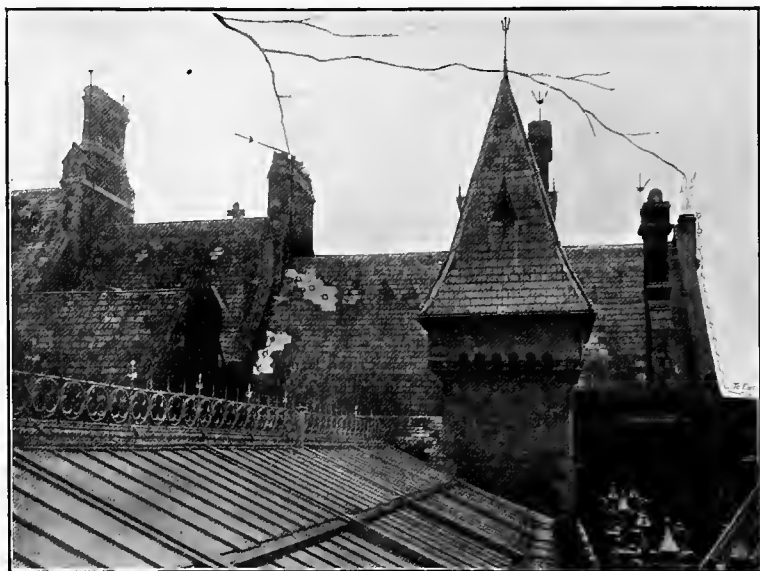
FIG. 50.

No. 67. **Near Heathfield, Sussex.**—This house, which had lightning rods fixed on every chimney, was struck in June, and again in August, 1902. The latter stroke is an example of a divided B flash, part of which fell on a chimney stack, bending the rod as shown on Fig. 50. A small unprotected statue about 40 feet

NOTE.—The futility of relying on individual rods without some system of inter-connection (see suggestion L.R.C.) is practically demonstrated, also the necessity of connecting up the smallest piece of metal work, as the iron support of the statue was selected in preference to the adjoining rods, whose air terminals were considerably higher. The circles $\circ \circ \circ$ show the paths of the discharge.

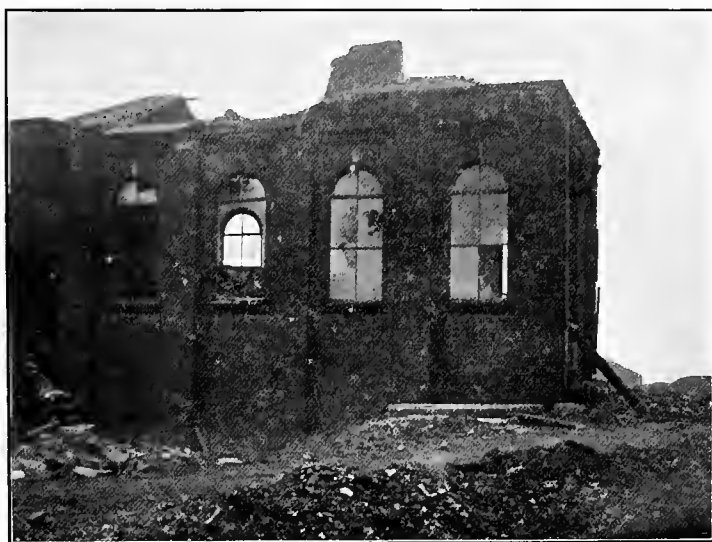
FIG. 53.

No. 86. **Ainsworth Mill, Lancaster**, February, 1903.—The buildings consisted of a stack, about 60 feet high, 15 feet square at base; adjoining this was the engine-house. A conductor was on the chimney on the north side and ran to earth near the water lodge. The flash struck the chimney, the lower part first giving way, crashing through the engine-house, and completely burying the engine. Bricks were thrown violently in all directions, and for a radius of 300 yards scarcely a house escaped without a number of broken windows. Fig. 53 shows the exterior of the engine-house after the stroke.

NOTE.—There is some doubt as to the continuity of the conductor; if this was imperfect, it would account for the breakage where the stone base joined the brickwork.

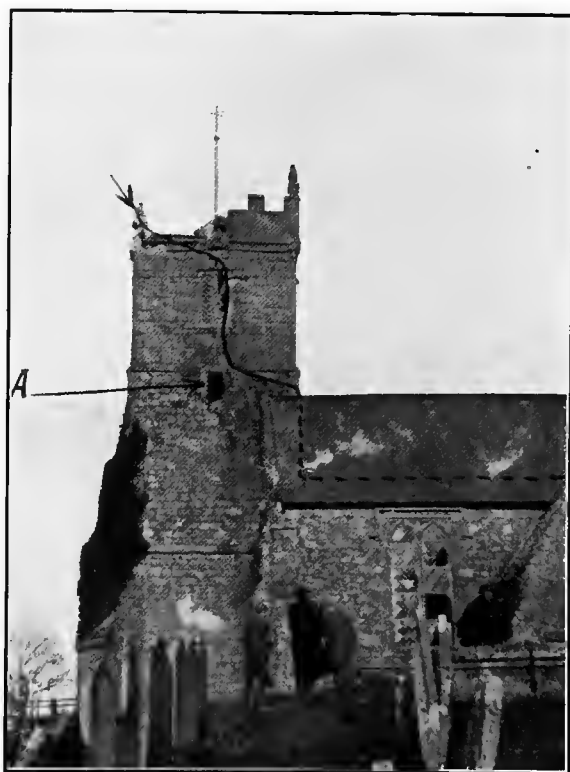
FIG. 58.

Fig. 58. The lightning, missing the flagstaff, struck the pinnacle and parapet, passing between the latter and the lead flat forming the tower roof, which was uninjured, acted as an explosive inside the tower, destroying the stairs, clock casing (marked A), and deal paneling, falling on the tower arch next to the nave, broke

all the windows, dislodged the basin of the font from its pedestal, doing minor injuries inside the building. The walls of the tower, 3 feet thick, were forced open at the quoins, and the clock face blown some 50 yards from the tower.

NOTE.—The course of the flash is shown by the dotted line, and the case is interesting for two distinct reasons: First, that the high flagstaff, with metal vane, which certainly was a more salient feature and a better conductor than a stone pinnacle, was untouched, and, secondly, although the church had been previously struck in 1778 and in 1897, the insurance companies have not insisted on any system of protection. Fig. 59 is the end elevation; **D** is the stove pipe (part of the flash went to earth near the base of this pipe); **E** is a lead gutter; Fig. 60 is a plan; **A** is point of first contact; **B**, stove pipe; **C**, damp place where earth was found.

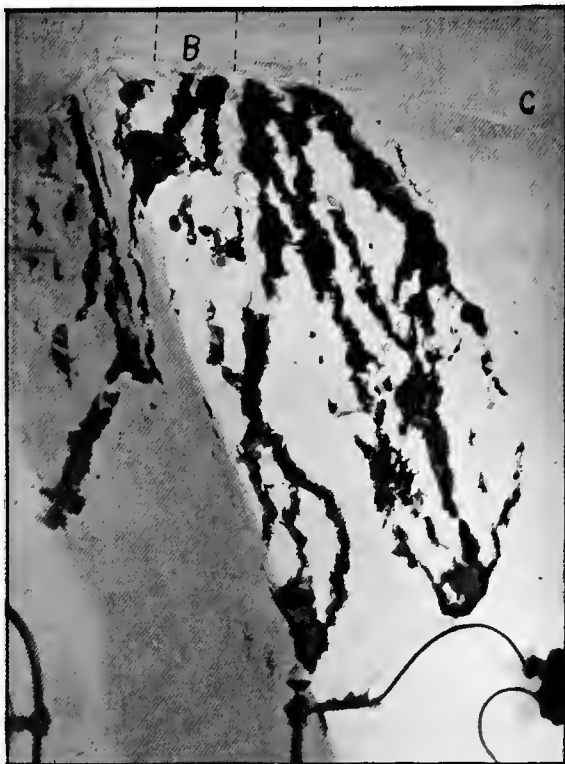
FIG. 64.

No. 45. **Cottages near Lewes, Sussex**, August, 1901. Observer: H. C. Card.—Fig. 64 is taken from a photograph of the interior of the upper room of a cottage where two people were sleeping. The progress of the flash from the base of the chimney (shown by dotted lines) is illustrated by the dark marks on the plaster; probably only a small portion of the flash entered the room, escaping by perforating the sides of the roof in several places. The bedsteads do not appear to have been touched; although it was said that "the occupants were thrown out," they more likely jumped out in their fright, as they were not severely hurt. The ceiling was on a slope from **B** and **C** upwards.

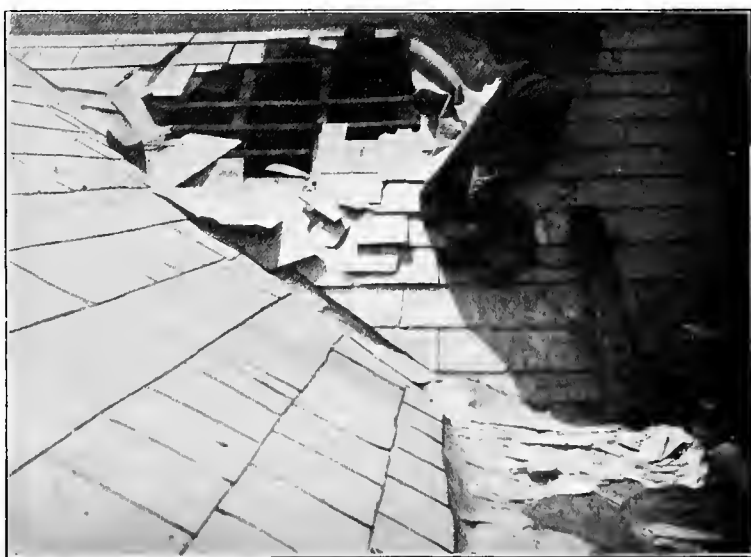
FIG. 67.

No. 27. **Palmerston House School, Ross, August, 1901.** Observer: Mrs. Evans, Principal.—This large stone building, the highest house in the immediate neighbourhood, was struck about 2 a.m., the lightning damaging the roof, Fig. 67, just above

where four boarders were sleeping; they were uninjured, but the furniture was considerably damaged.

NOTE.—The comparatively small damage was probably due to the very heavy rain, which allowed the greater portion of the stroke to escape down the walls, while a side flash only entered the building.

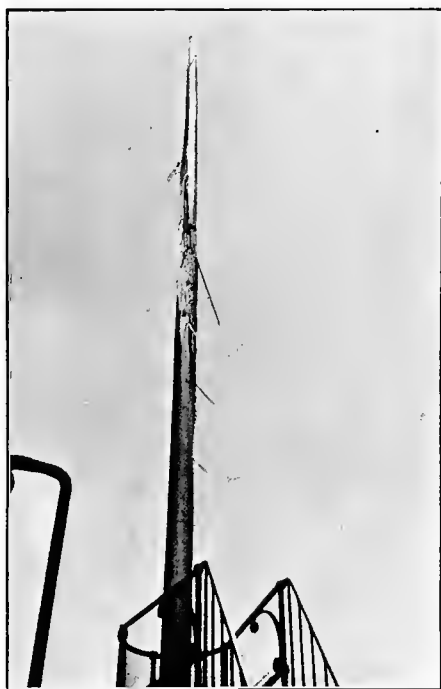
FIG. 69.

splintered, see Fig. 69, but no further damage occurred. It was reported that the flash was seen passing from one iron portion to another.

NOTE.—This is confirmatory of the opinion that lightning striking iron-frame buildings is often dispersed without damage to their structure.

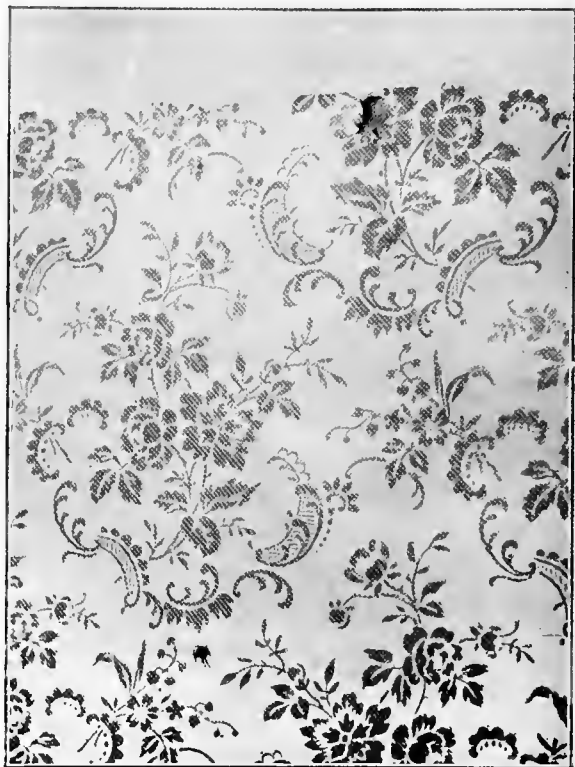
FIG. 70.

NOTE.—The interesting feature of this case is the effect of one portion of the flash, which perforated the brick wall ($1\frac{1}{2}$ bricks thick) of the schoolmistress's house, where the pipe hook supported the gutter. It made a hole about $\frac{1}{2}$ inch wide, then jumped to a nail on which a small gilt frame was hanging, playing over the gilding, which appeared as if washed off; it then again pierced the wall near the bottom of the frame and escaped by the pipes. The Fig. 70 is taken from a photograph of

the wallpaper and shows the holes where the flash entered and left the room.

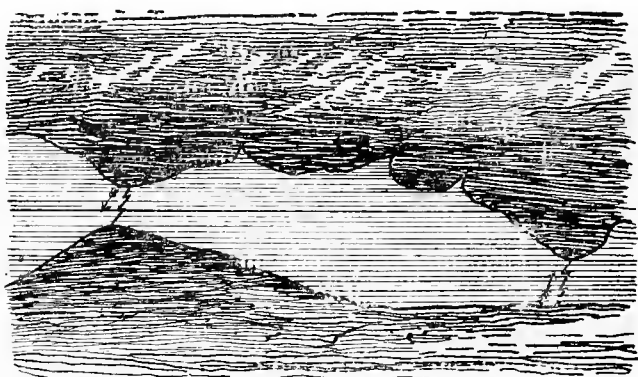
again escapes to a cloud. The illustration shows a downward discharge taking place at one point and a corresponding upward discharge is shown at some distance away.

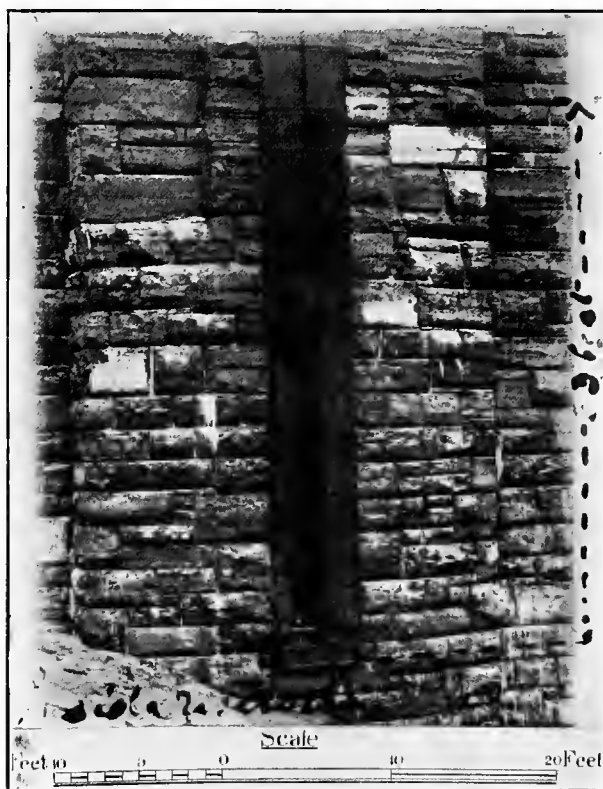
FIG. 74.

Myrthyr Tydfil Waterworks. Cracking of cast iron plates. Observer: George F. Deacon, M.I.C.E.—In the

dam used for impounding water was a vertical recess 50 feet long by 5 feet wide. The face was closed by ribbed cast-iron plates about $\frac{3}{4}$ inch in thickness, see Fig. 74. The plates were loose in the brickwork, and the pressure of water was equal on both sides. In December, 1902, the water was drawndown, when the whole of the plates for 33 feet from the bottom were found to be

cracked. The highest valve plate, shown by line on Fig. 74, was star cracked, and from out of the crack on this plate the main crack passed for 30 feet downwards through all the plates and flanges, and several large masses had fallen away. The iron was tested by Professor Unwin

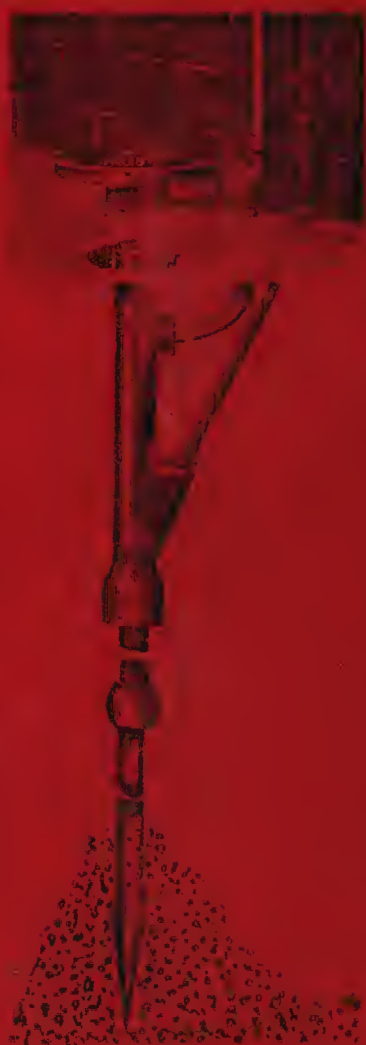
PATENT
TUBULAR EARTH
FOR
LIGHTNING CONDUCTORS.

No
Testing
required,
as the
Conductivity
of
this
automatically
moistened
Earth
is
constant.
